Trinity Church

in the City of Boston

The Church Endangered by the Low Level of the Ground Water How the Danger has been Temporarily Averted

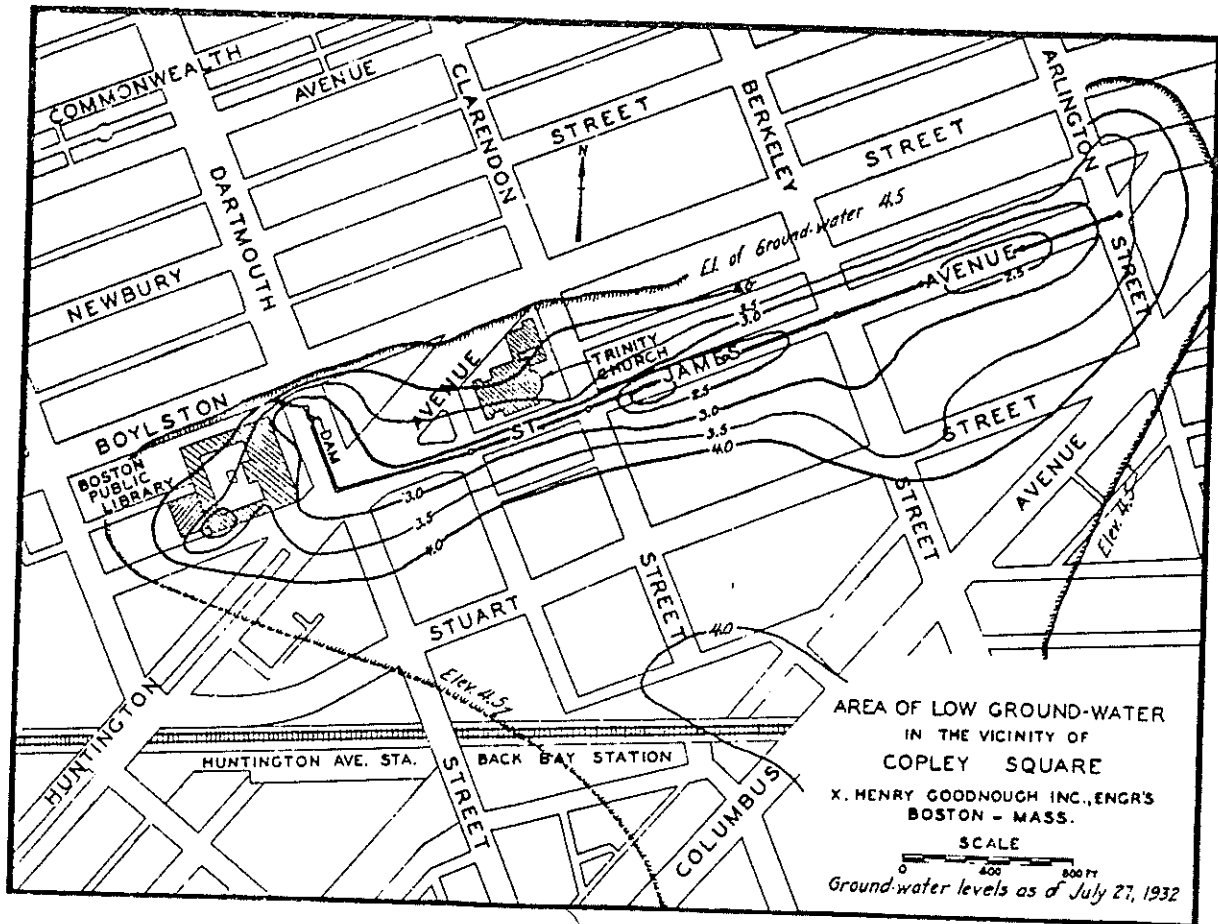
CONTOUR MAP OF WATER LEVELS

They were now enabled, through these many test wells located at strategic points, to set up the picture in tabular, graphic, and contour form. The *Contour Map of Water Levels* was most convincing, showing the lowest level to be along St. James Avenue and Dartmouth Street, and then as you went further and further away the contour lines rose higher and higher.

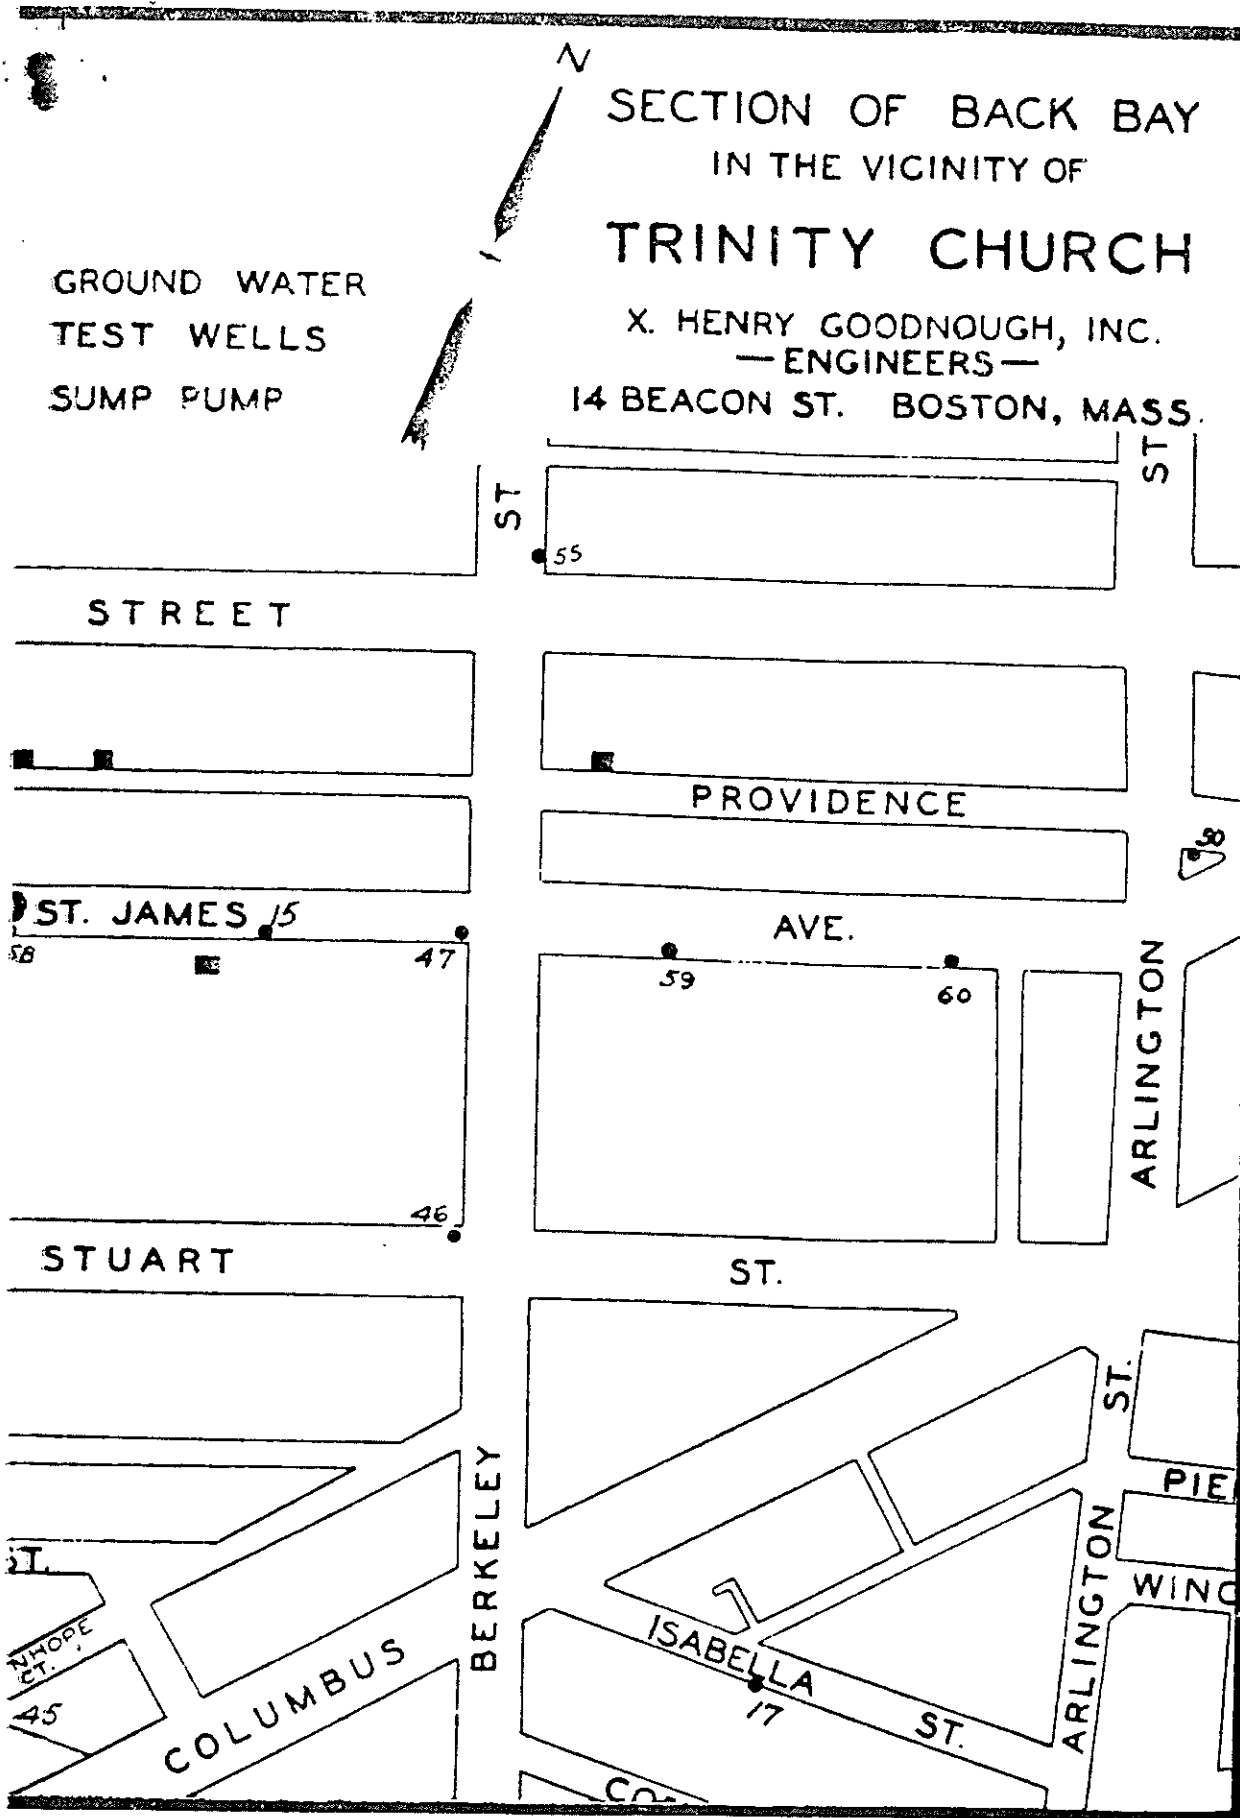
SECTION OF BACK BAY
IN THE VICINITY OF
TRINITY CHURCH

A map of the territory in the immediate vicinity of Trinity Church will be found on pages 10 and 11. This map shows where the various test wells were driven and the numbers attached to them, and also the location of the nearest sump pumps.

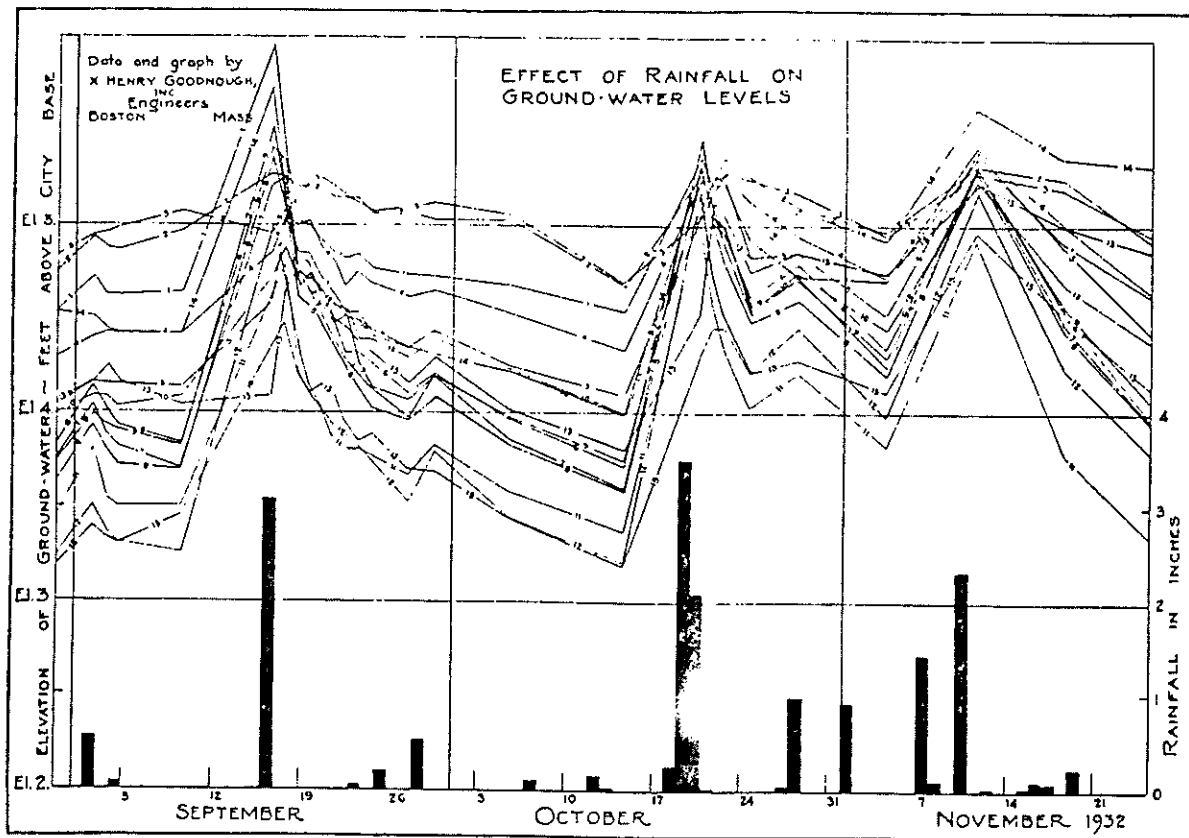
RAINFALL CHART

The above chart necessarily exhibits only a portion of the whole period studied, and, for the sake of clearness, refers only to the holes nearest to the Church.

One more link in the evidence was set up in a striking diagram showing *the effect of rainfall*. During the summer the drought was broken by heavy downpours which caused the holes to rise in marked degree, but after the rain had ceased the levels began to fall. Those holes which were lowest showed the greatest rise and also were the first to fall. The sewer could not handle or carry away the full rainfall, but naturally, after the rain had ceased, affected first those holes which were nearest to any leaks into it.
