## Biodegradation of Untreated Wood Foundation Piles In Existing Buildings

### Part 2 – Deterioration Mechanisms

By Milan Vatovec, Ph.D, P.E. and Paul L. Kelley, P.E.

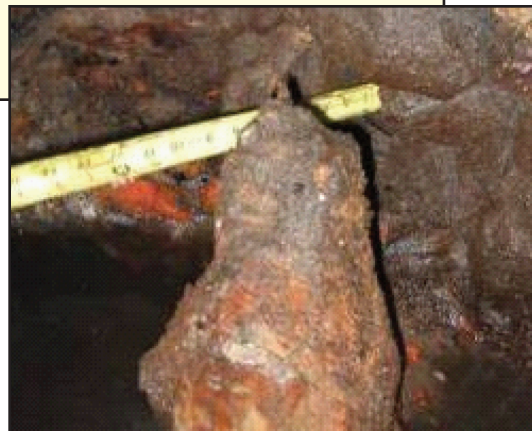
Figure 1: Pile deterioration is so severe that contact with the underside of the pile cap is lost. Note the pencil-top shape indicating attack direction (outside-in).

- the appearance and structural makeup of the exposed piles are obviously altered;
- pile tops are soft and punky;
- shape and cross section near the top are changed - i.e. pencil-top-like, or a complete disconnect with the underside of pile caps (*Figures 1 and 2*);
- piles provide no significant resistance to probing (*Figure 3*) and provide no meaningful support for the structure; and
- the groundwater table is often found to be below pile tops, or even worse, the soils can be dry (*Figure 4*). This also probably means that the groundwater table had likely dropped and stayed low for prolonged periods of time, exposing the pile tops to oxygen and allowing significant deterioration.

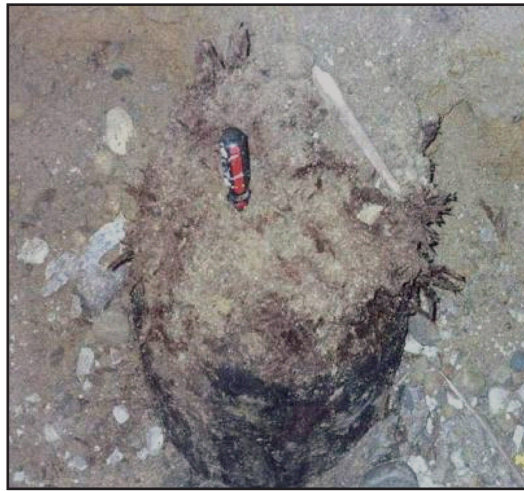
*Figure 3: This interior pile, once the column footing was removed, showed no resistance to probing. Groundwater receded a long time ago.*

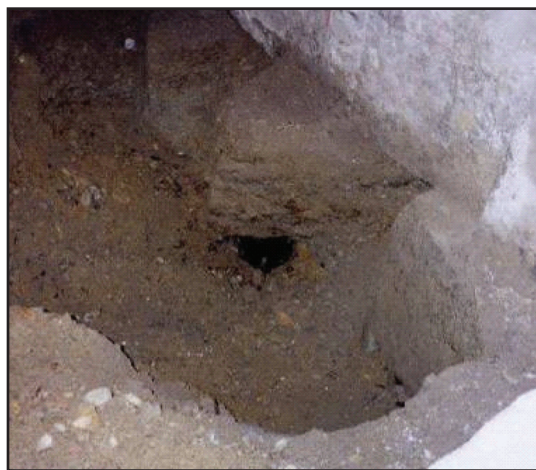
*Figure 4: Excavation revealed decayed piles. Groundwater was not encountered and the soil is dry.*

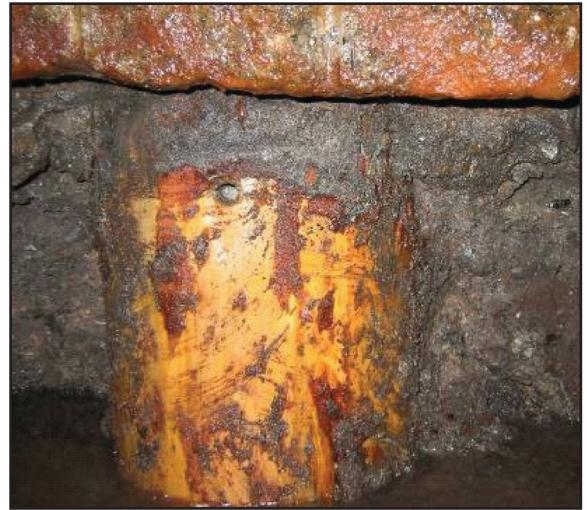
Figure 5: Exposed piles appear to be in good condition. Piles are thought to have continually been in a submerged condition – no damage is expected.

- soil makeup,
- nature of oxygen exposure (water fluctuation),
- presence of chemicals in the soil or water,
- wood species and their natural decay resistance, and
- individual pile properties (Figure 5, see page 55).

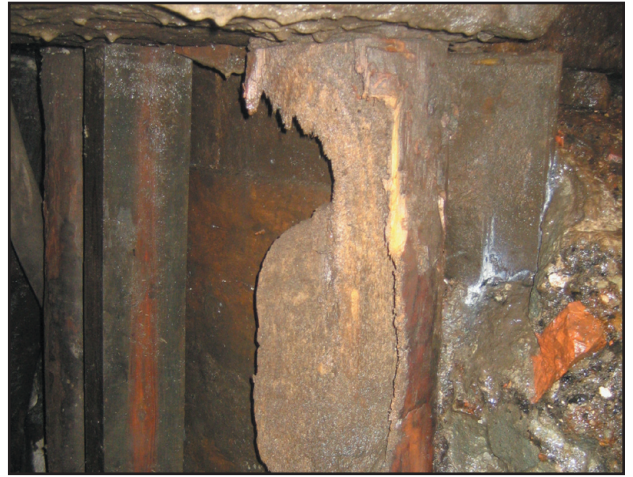
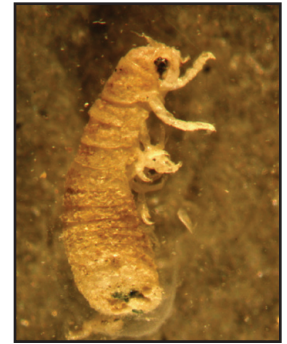
Figure 7: Marine-borer damage to a buried pile exposed through excavation (above). *Limnoria* exoskeleton is shown to the right. Live borers were also found.

Marine borers are usually recognized as a threat only to marine and bridge pier piles where wood is exposed to flowing water. However, they also appear to be able to attack building piles in soils below the groundwater table. During a recent project that involved a waterfront structure, significant pile deterioration caused by limnoria (gribbles) was found in a number of interior piles. The piles are buried in soil located on the land side of a granite seawall, and portions of some of the piles (mostly located within the tidal zone) were literally consumed by the borers (*Figure 7, see page 56*).

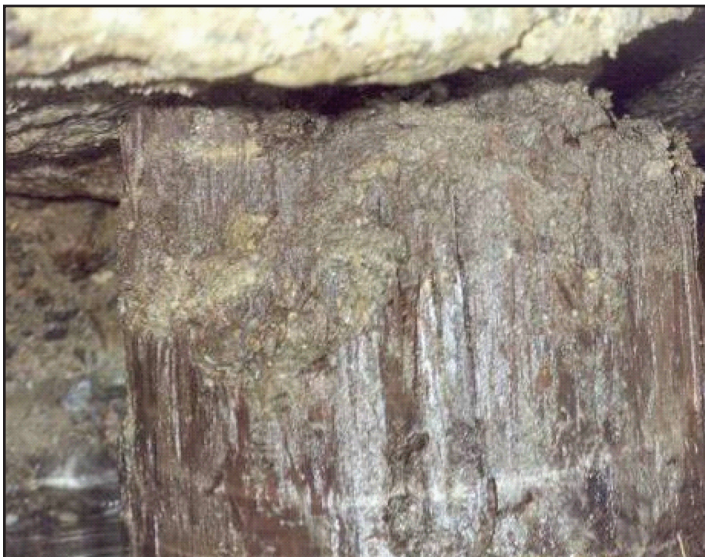
Figure 6: Pile appears in good condition, but later analysis found the pile to be significantly deteriorated. Groundwater is drawn down by pumping.
