BOSTON GROUNDWATER TRUST (BGwT)
BOARD MEETING
November 17th, 2016

BOSTON GROUNDWATER TRUST PRESENTATION

Chris M. Erikson, P.E.

McPhail Associates, LLC

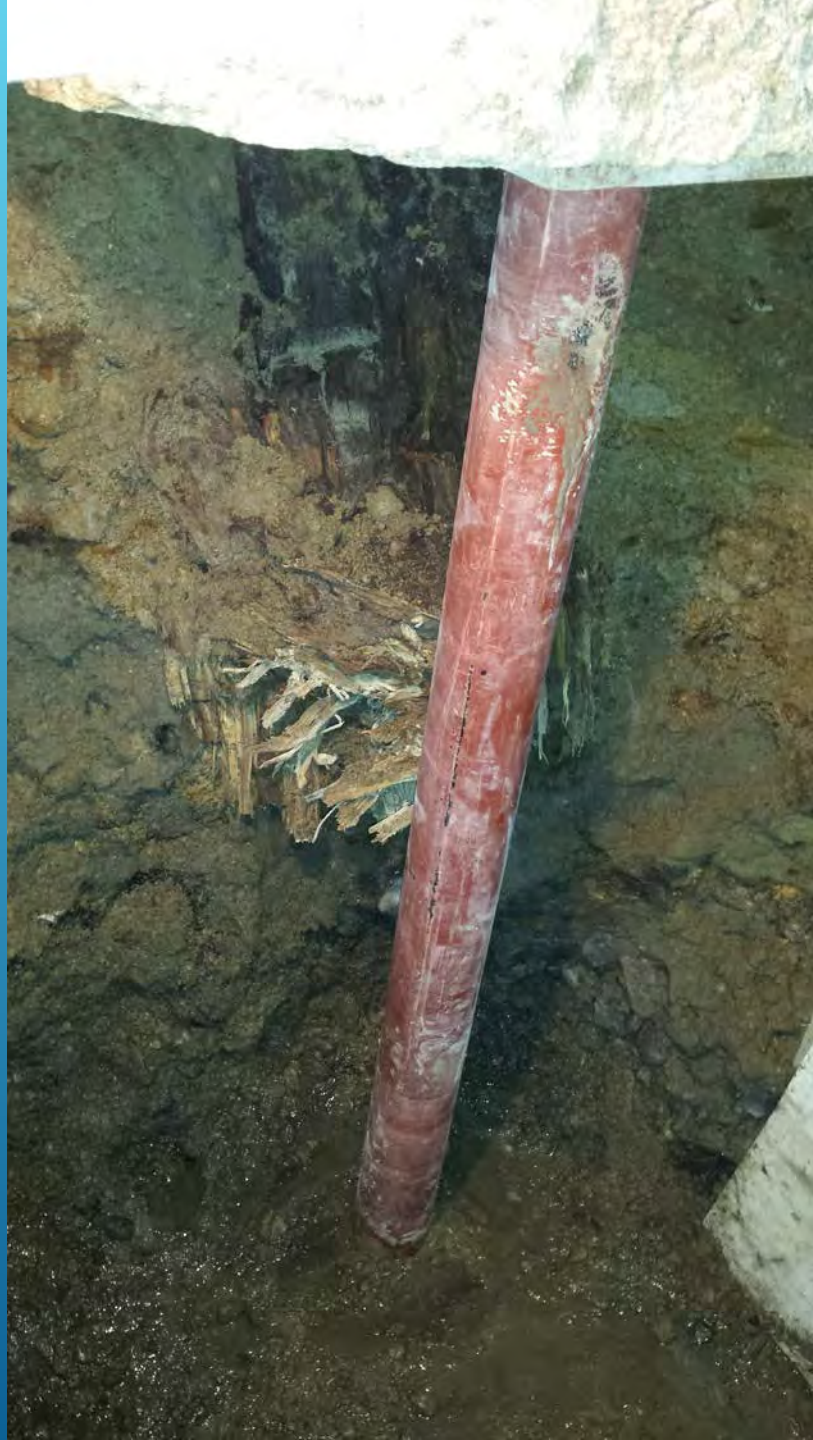
ELEVATION VIEW - TYPICAL UNDERPINNING PIT
WITH BROKEN PILES PRESENT
SCALE: 1/2" = 1'

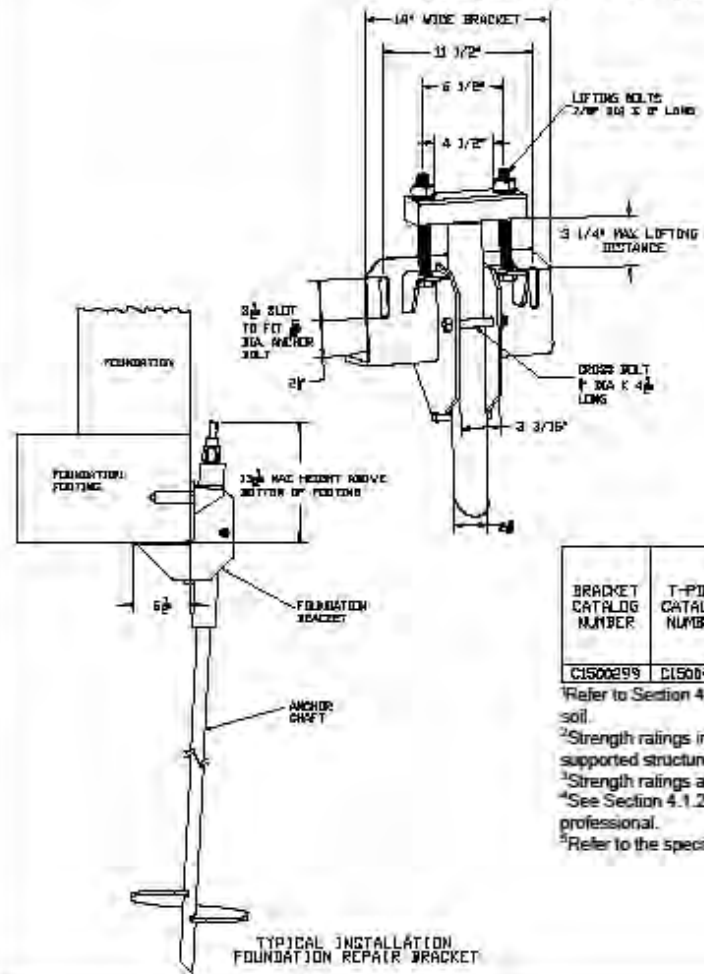
STANDARD UNDERPINNING BRACKET AND T-PIPE
FOR CHANGE TYPE SS175 HELICAL PILES

1. HOT DIP GALVANIZE PER ASTM A153-LATEST REVISION.
2. ASSEMBLE COMPLETE AS SHOWN IN SIDE VIEW.
3. THE NUTS ON THE LIFTING BOLTS AND CROSS BOLTS MUST BE TIGHTENED TO ACHIEVE A SNUG-TIGHT CONDITION AS DEFINED IN SECTION 3.3 OF AISI 360-85; AS A MINIMUM, NUTS MUST BE TIGHTENED 1/4 TURN BEYOND HAND TIGHT CONDITION. DO NOT EXCEED 165 FT-LB OF TORQUE ON LIFTING BOLTS DURING STABILIZATION OR LOAD LOCK OFF.

4. RECOMMENDED ANCHOR SHAFT CUTOFF LEVEL ABOVE THE BOTTOM OF THE FOOTING IS 10" TO 11" FOR MAXIMUM LIFT DISTANCE.
5. FOR DETAILED INSTALLATION INSTRUCTIONS, READ CHANGE BULLETIN 01-590E.

6. MATERIAL SPECIFICATIONS:
BRACKET BODY : PER ASTM A36 AND ASTM A570 GR. 50.
T-PIPE TUBE : HOT ROLLED MECHANICAL TUBING PER ASTM A500.
LIFTING BOLTS : HEX HEAD BOLT PER ASTM A325, TYPE 1.
CROSS BOLT : HEX HEAD BOLT PER ASTM A325, TYPE 1.

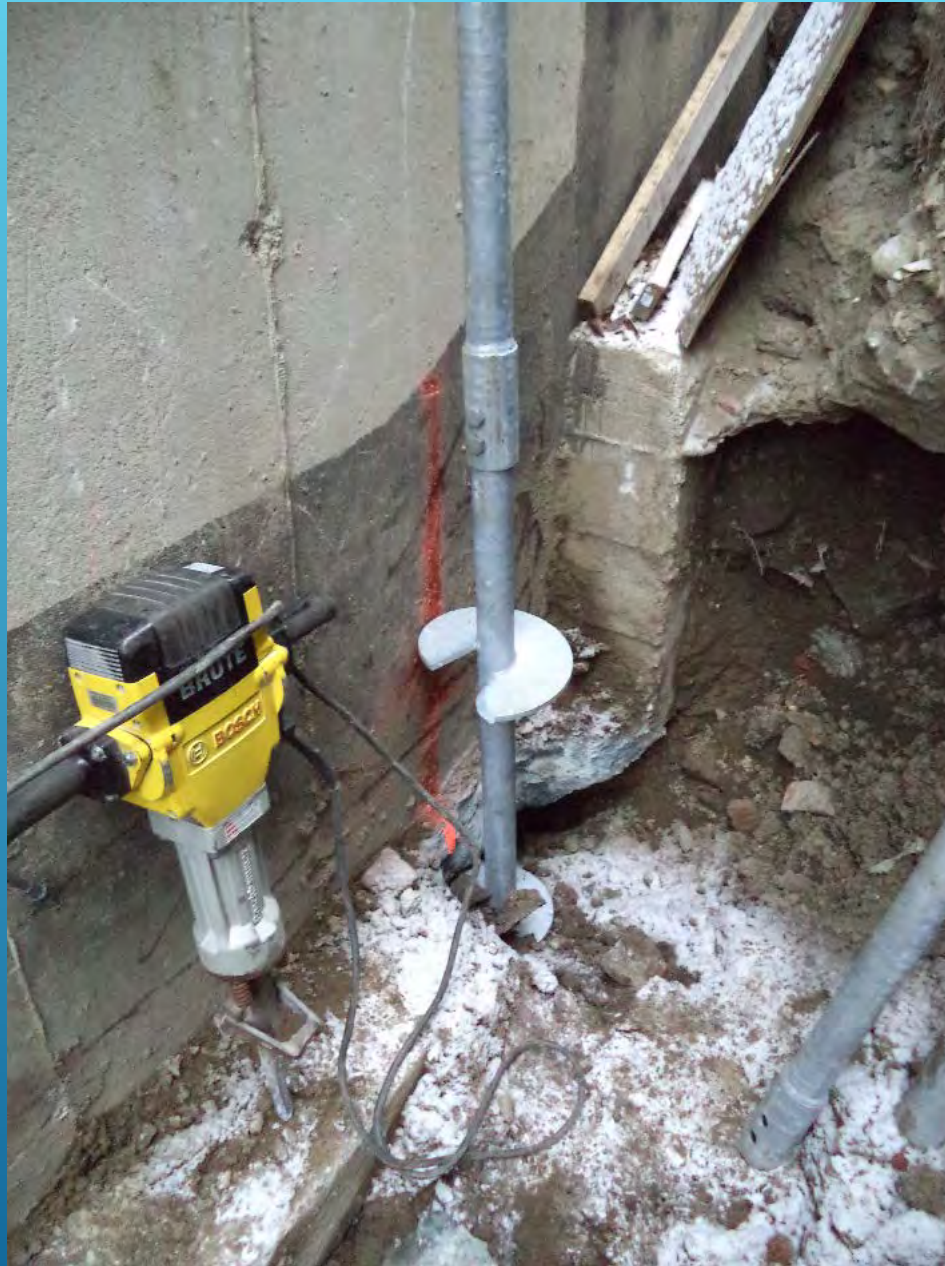
TYPICAL INSTALLATION FOUNDATION REPAIR BRACKET

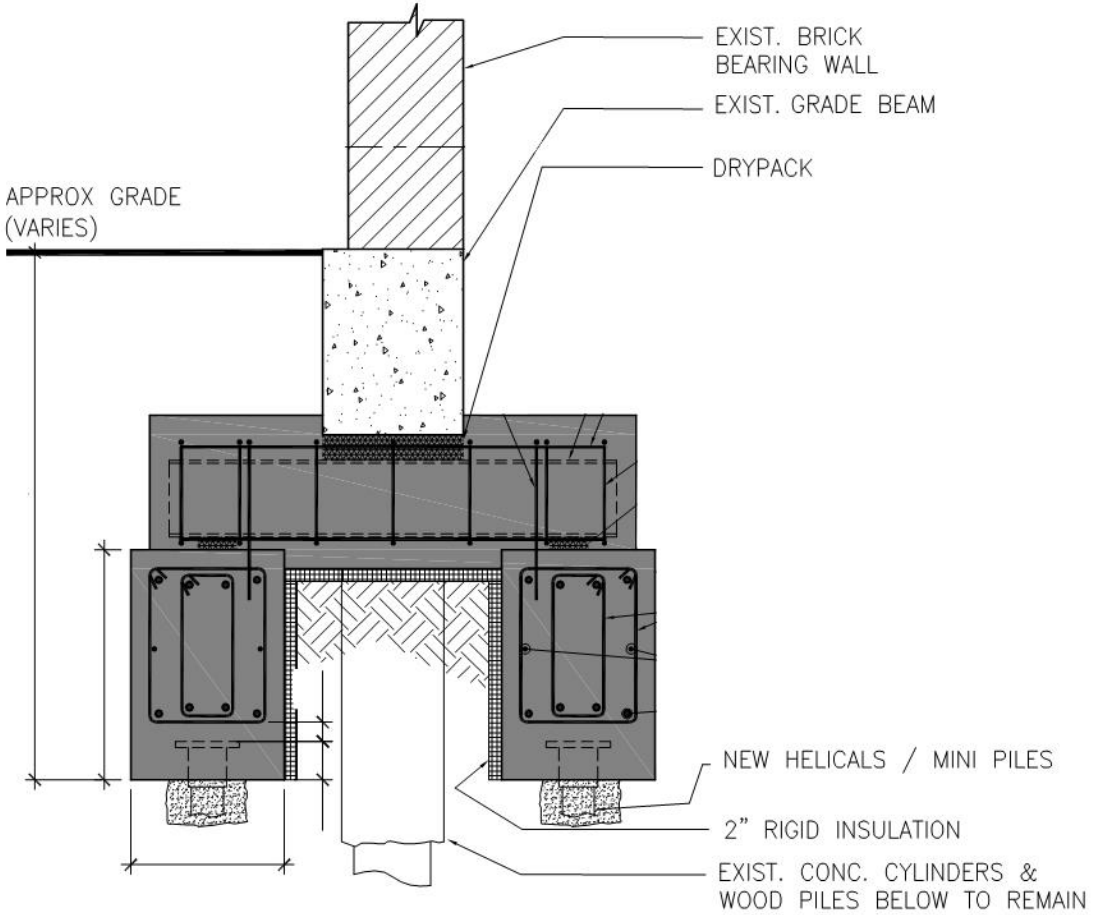
ALTERNATE FOUNDATION REPAIR OPTION

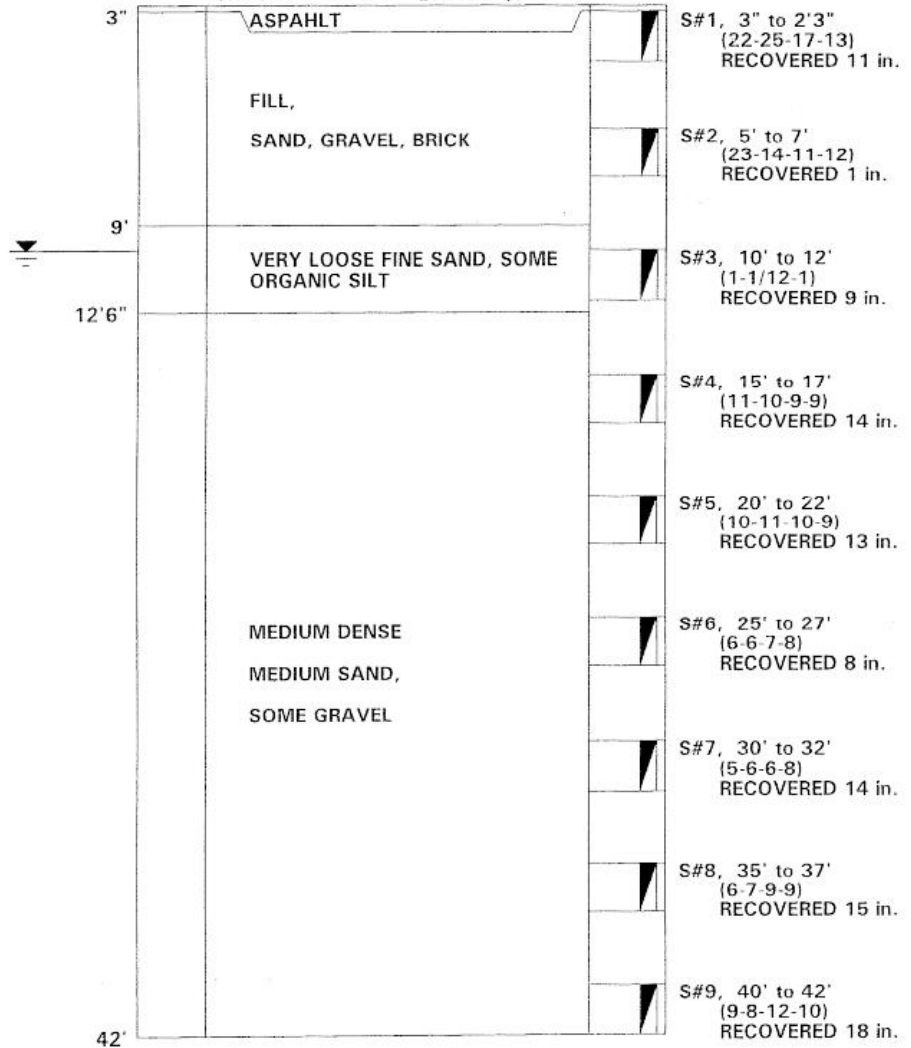
BORING 1

GROUND SURFACE EL+19.2

WATER LEVEL 10'
SIZE OF CASING: NW, LENGTH: 40'0"
DRILLER: JOSEPH DESIMONE, INSPECTOR: JENNIFER RAUCH
DATE STARTED & COMPLETED 11-10-2004
