# Proposed Low Groundwater Solution

*Senior Design Project*

*Civil & Construction  
Engineering*

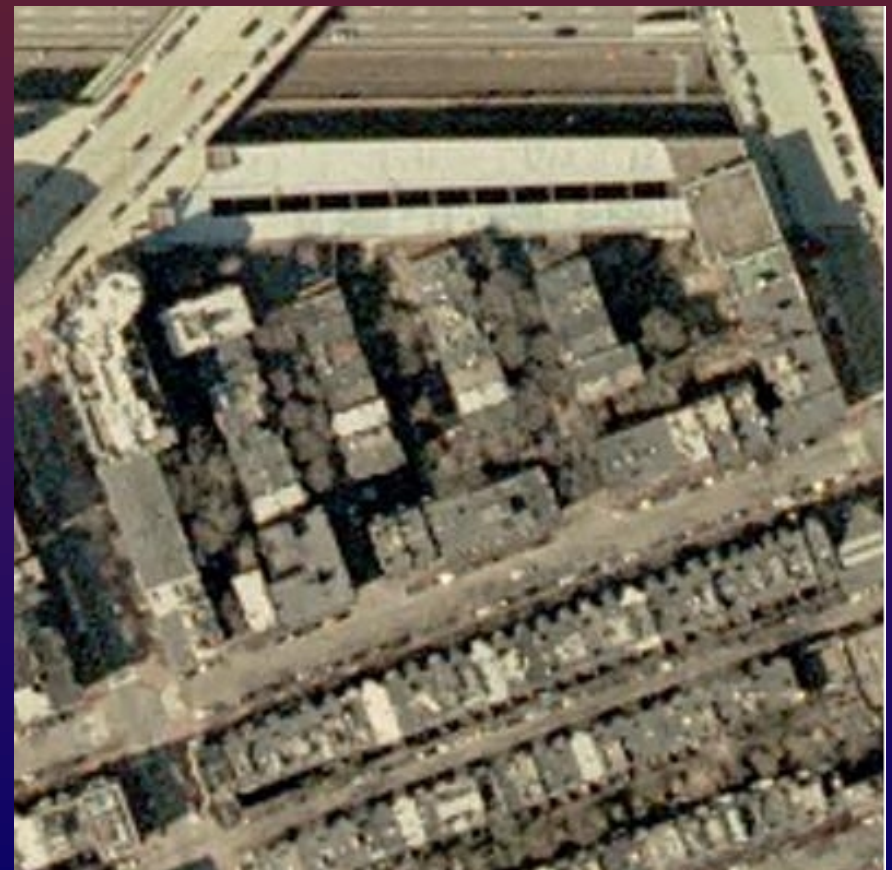
2004

# Neighborhood Location- South End, Boston

- ❖ Next to Back Bay Station & Mass Pike
- ❖ Berkeley St, Clarendon St, and Chandler St.

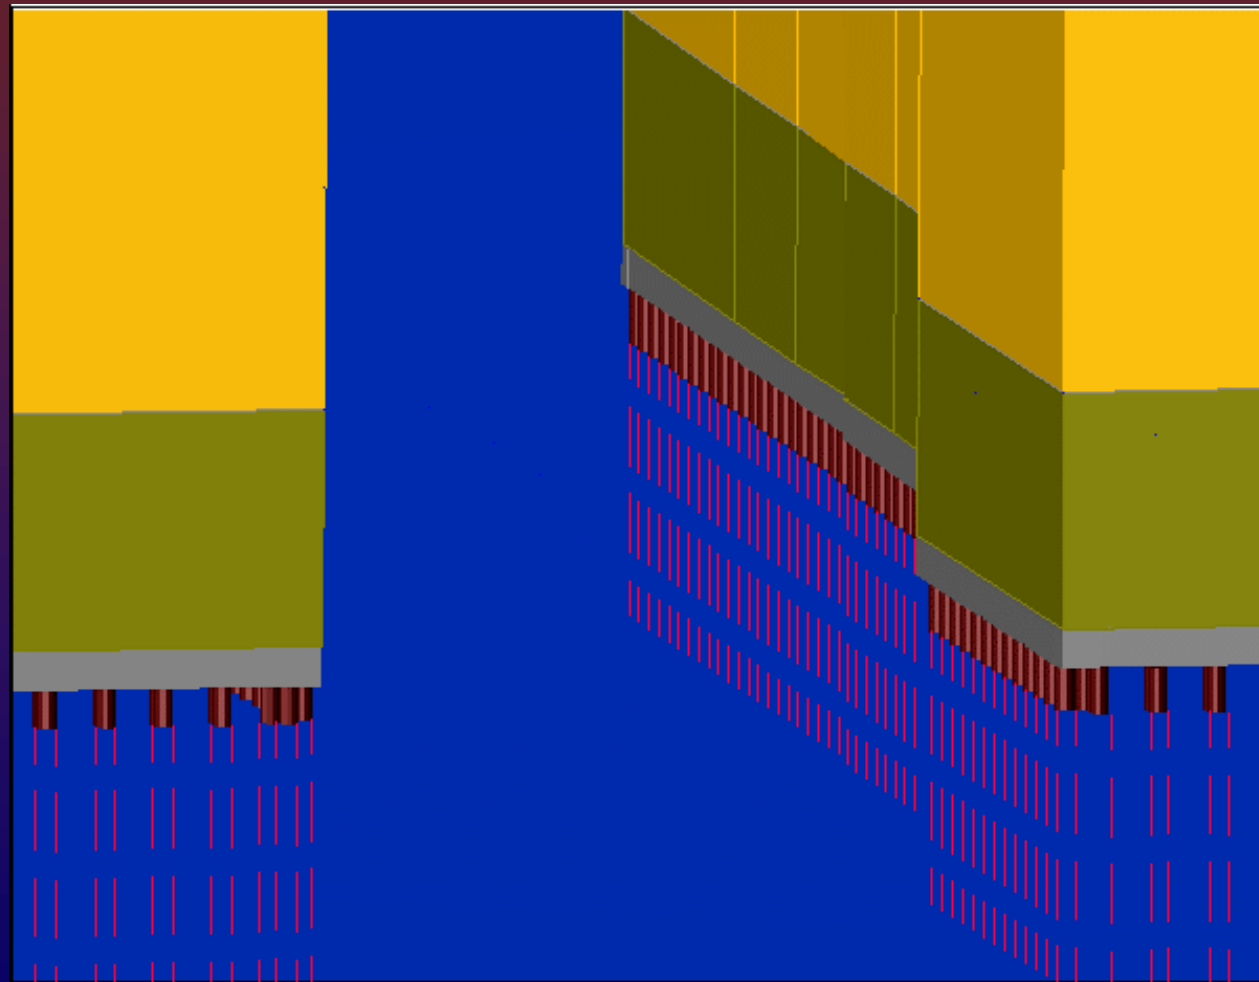
# Exposed Piles & Low Groundwater

- ❖ Area of design project has a persistent problem of low groundwater
- ❖ A recharge system has been set at St. Charles St.
- ❖ Wood pile tops will rot if not submerged under groundwater

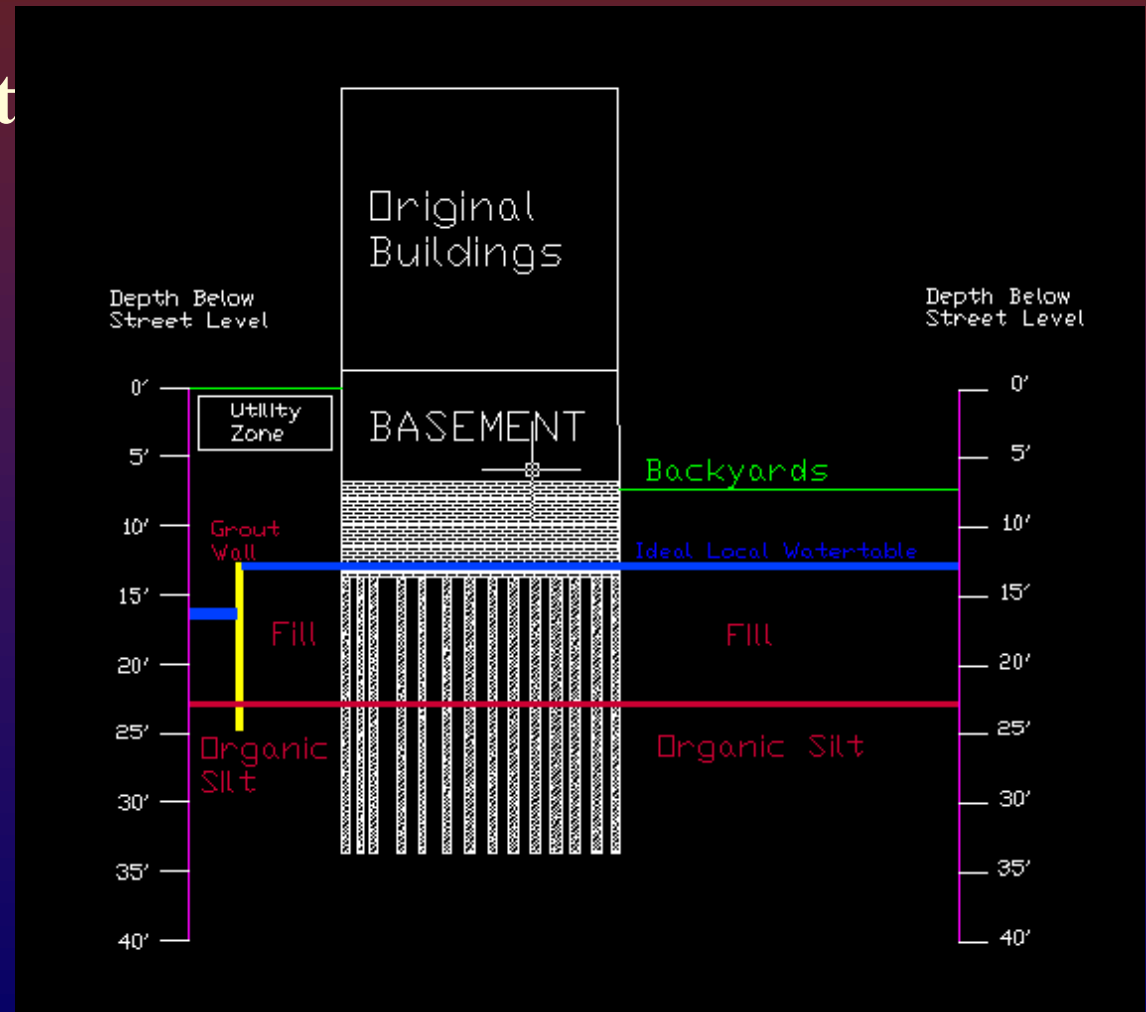
# Typical Profile

- ❖ Depths Below Street
- ❖ Basement: 6'
- ❖ Top of Piles: 14'
- ❖ Organic Silt: 22'
- ❖ Grout Wall
  - ❖ Top: 13' & 12'
  - ❖ Bottom: 25'

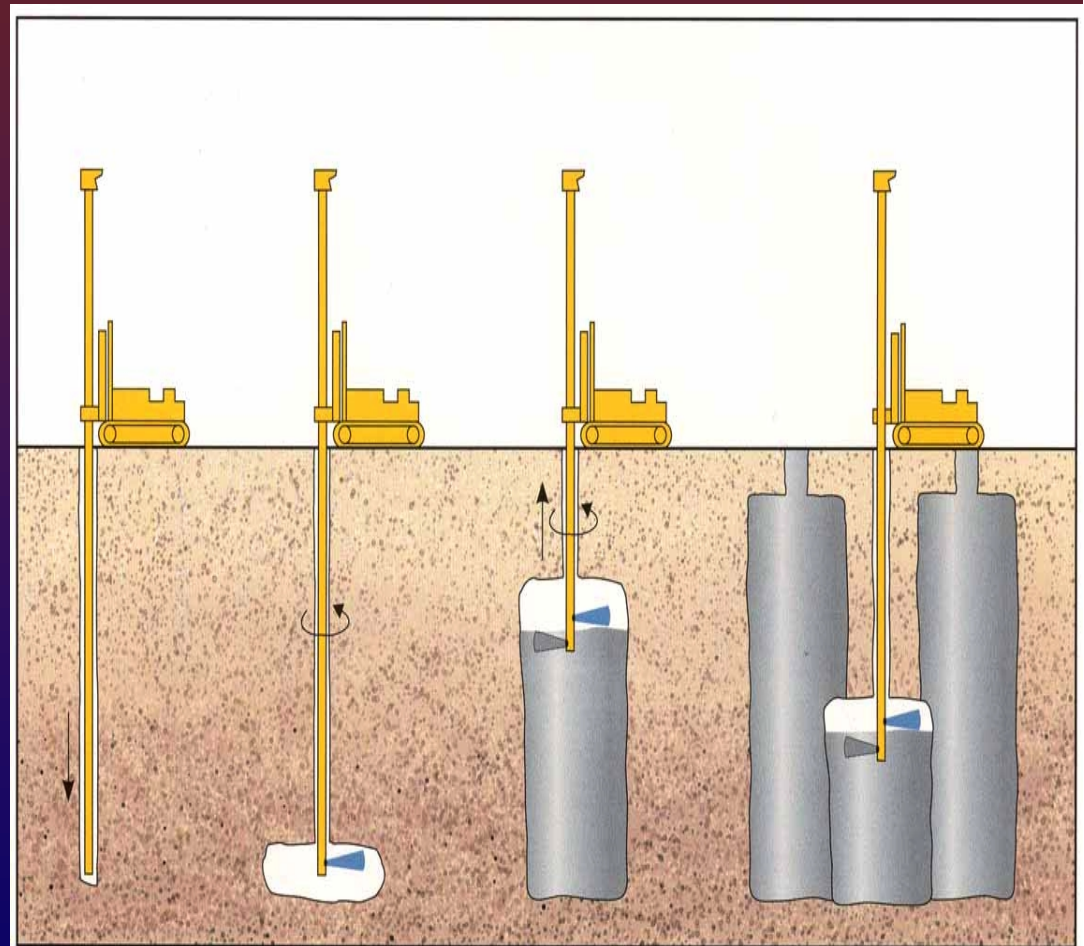
# Installation-Jet Grout

- ❖ 4" dia. installation holes drilled to desired bottom elevation every 4' +/-
- ❖ Curtain started @ desired depth
- ❖ Curtain is formed up to desired top elev.
- ❖ Wall sections installed incrementally
