NOVEMBER // DECEMBER 2019

The Geotechnical Intrigue of Boston's Back Bay

By Jim Lambrechts, PE, M.ASCE

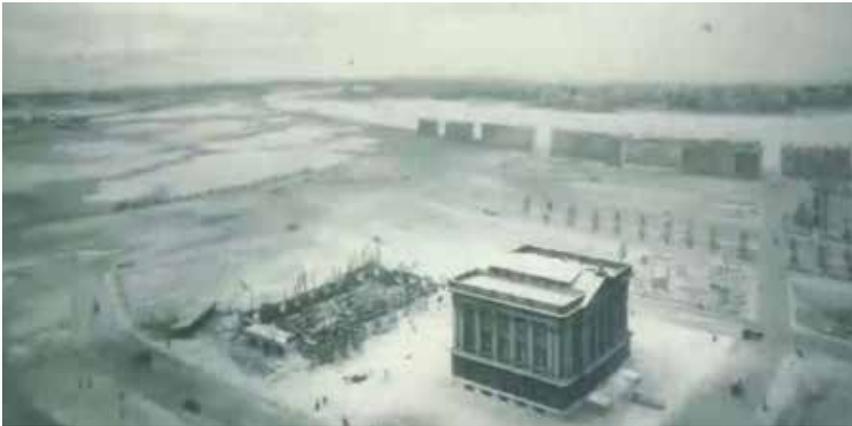
Figure 3. Development quickly followed Back Bay land filling. (From the collection of Edmund Johnson of Haley & Aldrich, received 1995.)

Building development quickly followed the filling, as illustrated in Figure 3. Four- to five-story-tall brick rowhouses were constructed on wood pile foundations driven by drop hammer 25 to 40 ft through the new fill and organic silt strata to substantial end resistance on the stiff clay crust or outwash sand above the blue clay. Granite blocks were used as pile caps, which limited pile spacing. Timber piles were used to support more than 2,000 buildings constructed throughout Back Bay in its first 30 years. Under the famous Trinity Church in Copley Square, 700 wood piles were reportedly used to support each of the church's four massive stone pillars, with about 4,500 piles required for the entire church.
