# Wooden foundation piles and its underestimated relevance for cultural heritage

René K.W.M. Klaassen\*, Jos G.M. Creemers

SHR Timber Research, Post box 497, 6700 AL Wageningen Netherlands

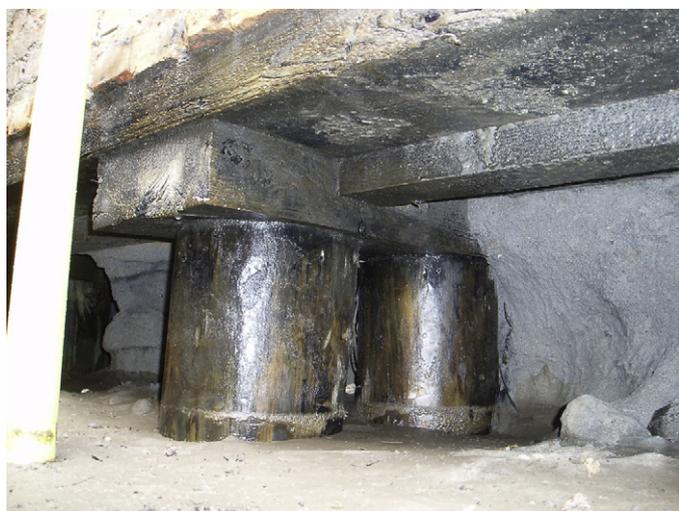
**Fig. 1.** A commonly used foundation construction in the Netherlands of pile pairs, the so-called *Amsterdam foundation type*.

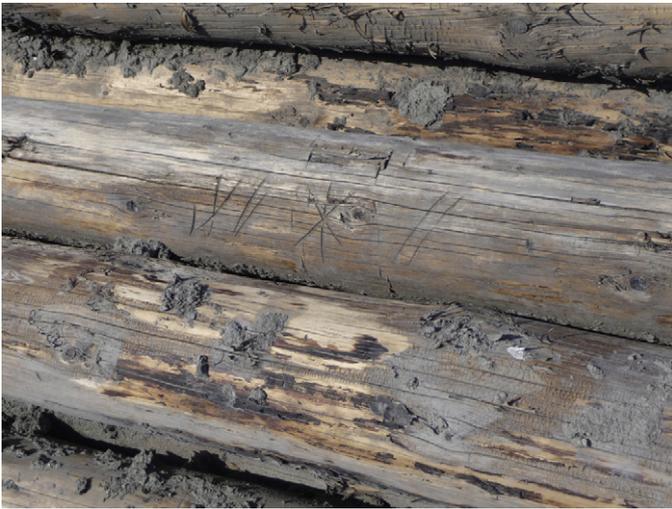
Fig. 3. Signs on pile tips of > 100 years old extracted piles.

Foundations are hidden in the soil and thus, are less acknowledged than above ground construction elements. Nonetheless, it is obvious that they are crucial for the stability and thus, lifespan of a building. Besides knowing that wooden foundations can fulfil their functions over hundreds of years, archaeological wood can be conserved sometimes for thousands of years in its wet and anoxic environment. The millions of wooden foundation piles used in the last millennia all over the world, offer a huge building history archive preserved in wet soils and are waiting to be explored. It can tell us about the progress in construction technology of building, as well as the development of the timber use (in species and quality). Specific marks at the pile tips applied by the craftsmen, traders or salesmen (Fig. 3) can provide information on the origin and on how the timber was transported. Tree-ring analyses on wooden piles enable us to exactly determine the cutting date and origin of trees that were used for foundations and hence make it possible to determine the approximate age of a foundation and to reconstruct timber trade across centuries, e.g. [8]. Wooden

foundations piles can therefore give additional information for historians to complete their understanding of the way of building in the past, e.g. [9].

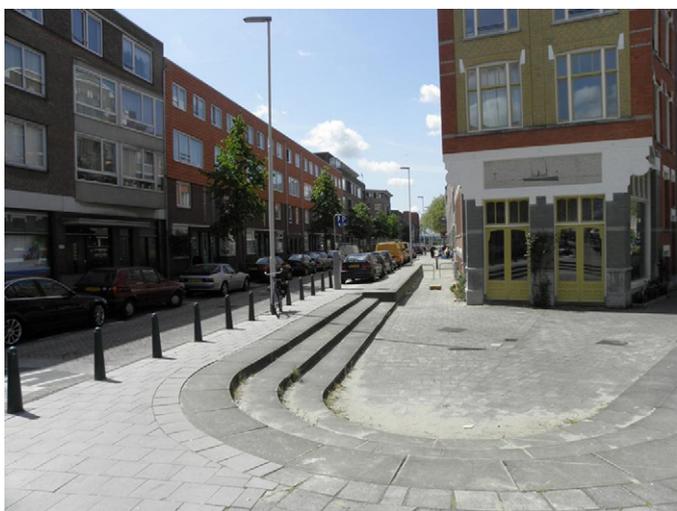
**Fig. 4.** Adaption of the street level to the houses with a high but homogeneous settlement because of negative skin friction, Rotterdam 2010.

The bearing capacity of wooden foundations under most buildings is overestimated. Nevertheless, additional load because of enlargement of the building or additional load because of surrounding sand layers were not taken into consideration. Especially, the so-called negative skin friction is a phenomenon that only after WWII was included in construction calculations. The problems with the *Beurs van Berlage* were related to this phenomenon. After a part of the river Amstel was closed, it was filled with sand and on this sandy layer the *Beurs van Berlage* was built. As the underlying weak Amsterdam soil (peat and clay) was compressed by the sand, within 5 years the heavy sandy layer was kind of 'hanging on' to the foundation piles, increasing the load on the piles tremendously and causing problems. The *Beurs van Berlage* is just one example but as sand layers were often used to develop new building areas, the problem is widespread over the Western part of the Netherlands (Fig. 4).

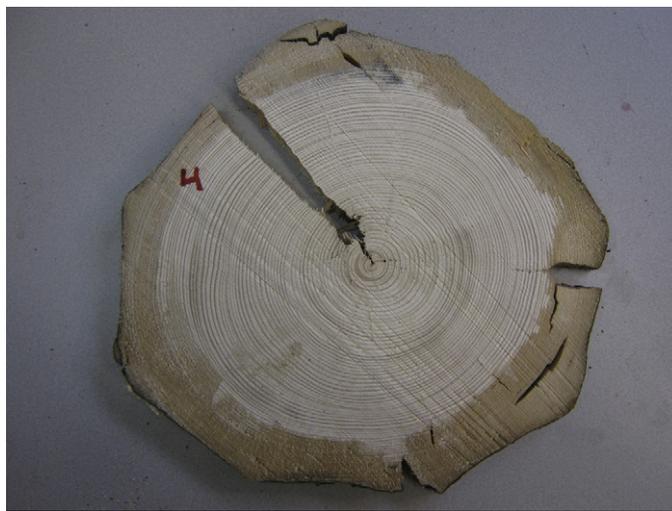
**Fig. 5.** Three-hundred-and-fifty-year-old spruce pile (∅ 16 cm) degraded in the sapwood only by bacteria.

[15–17]. In all Dutch wooden foundation piles investigated, bacterial decay was found over the full length but the intensity varies. In some piles, only the outermost 1 mm is degraded over a period of approximately 100 years, whereas in other piles, an outermost layer of 50 mm and more of decayed wood over the whole pile length can be caused by bacteria in 50 years. Although the process of bacterial wood decay is not yet fully understood, in the last decades much new knowledge has been gathered [18–43]. As wood degrading bacteria are in themselves immobile they need water flow for entering and colonising the wood and intermixture of the consortium species. Permeability of the wood and groundwater flux are believed to be the key parameters to determine the velocity of bacterial decay. Permeable wood structures that allow water movement, like alder, poplar and the sapwood of pine and oak are typically susceptible for bacterial decay. The amount of sapwood is in oak and especially in pine crucial for its quality as foundation pile because, within several decades, the sapwood can be fully degraded whereas the heartwood stays sound for hundreds of years, as shown in the pine heartwood foundation elements investigated from the 350-year-old *Amsterdam Royal Palace*. From the thousands of foundation inspections carried out in the Netherlands, spruce piles showed to be less susceptible for bacterial decay compared to pine. It is believed that this is related to the low permeability of the spruce sapwood. Although, compared to pine, the difference in sap- and heartwood of spruce is much more difficult to determine in the wood itself and more difficult to predict on the basis of tree age and stem circumference [44], evidence is found that also in spruce a sharp demarcation between sound heartwood and severely bacterially degraded sapwood is common in foundation piles (Fig. 5). SHR has a database, which was built up in the last 15 years and contains information on more than 5000 foundation piles, their location, species, building age, and type and intensity of the decay. This database shows that there are large differences in velocity of bacterial decay between cities e.g. velocities are low in Rotterdam and high in Amsterdam. In order to determine the velocity of bacterial decay, one should regard the speed in which the wood structure is invaded by bacteria and the speed of severe cell wall degradation caused by wood degrading bacteria. Ref. [31] offers a qualification system based on light microscopic observations and the first signs of decay (weak) is a tool to describe the invasion of bacteria in the wood and at the stage of severe decay, the timber is regarded to have lost almost all its compression strength. The SHR database show that the invasion velocity of wood degrading bacteria ranges between 0 and 1.1 mm/year and that of severe

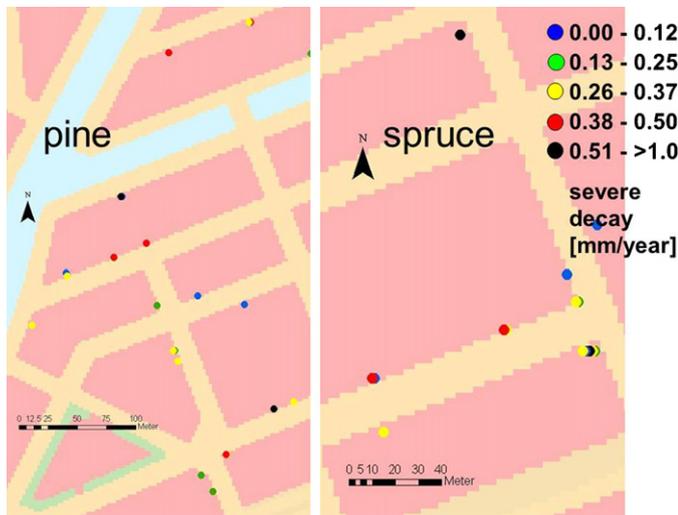
Fig. 6. Two locations in Amsterdam with piles of same timber species showing a wide variability in bacterial decay velocity.

A case study of the Amsterdam situation, showed that local variability in hydrology or soil chemistry are not related to bacterial wood decay activity. It was found that piles of the same species under one building can differ enormously in degree of bacterial decay (Fig. 6), and it is supposed that besides sapwood percentage, also wood quality and the handling around harvesting could be crucial in sensitivity to bacterial decay [35].
